# POSTERIOR COMPOSITE RESTORATION

WITH CLEARFIL MAJESTY™ ES-2 UNIVERSAL

## CASE BY DR ADRIEN LAVENANT

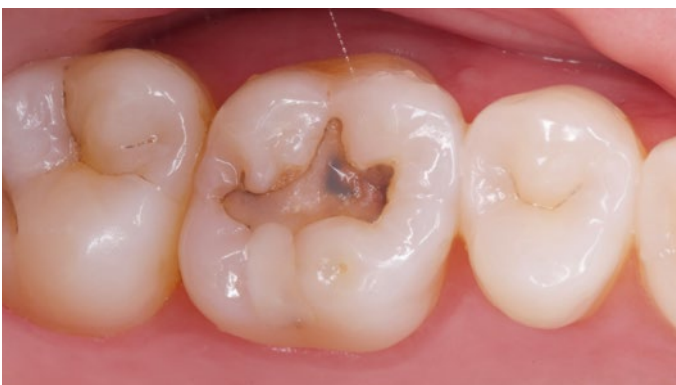
**Fig. 1.**

Initial situation showing an occlusal caries lesion on the maxillary right first molar.

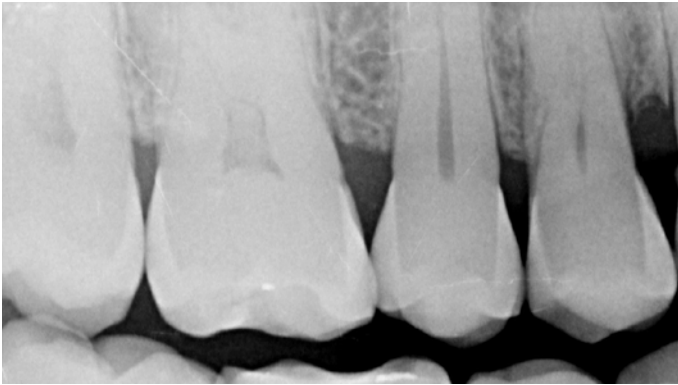
**Fig. 2.**  
Pre-operative X-ray.

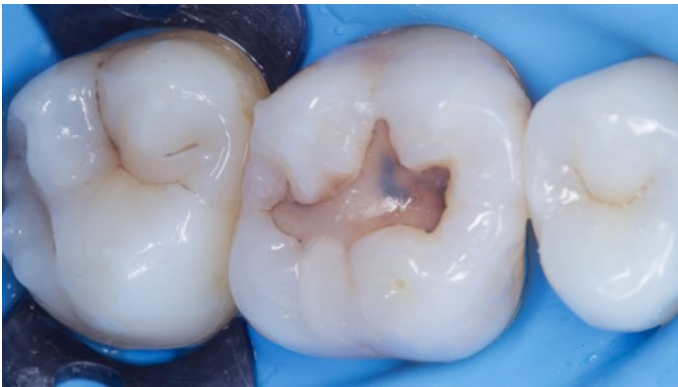
**Fig. 3.**  
Isolation of the working field with rubber dam.

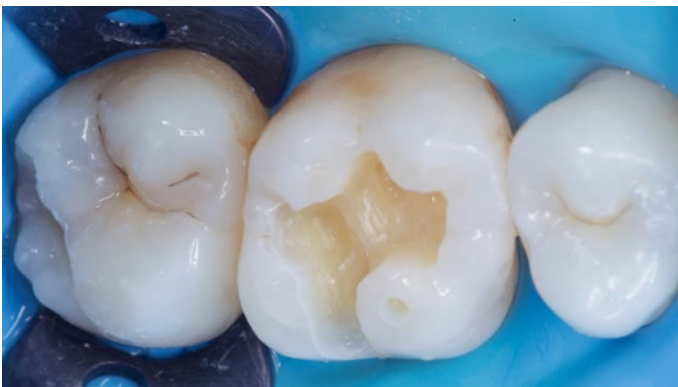
**Fig. 4.**  
Situation after caries excavation and tissue preparation.

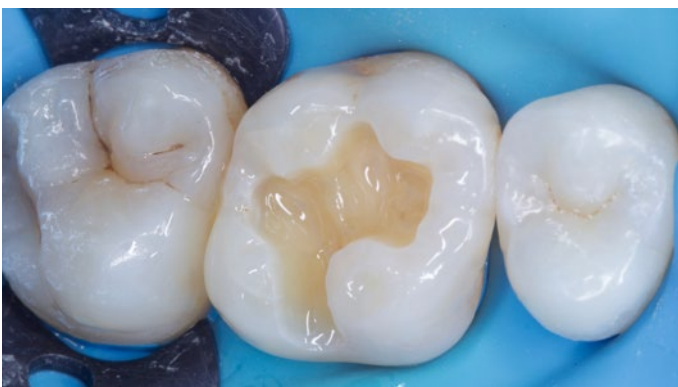
**Fig. 5.**  
Cavity ready for the application of the universal composite: CLEARFIL™ Universal Bond Quick is visible on dentin and enamel and the cavity floor is covered by a thin layer of CLEARFIL MAJESTY™ ES Flow Low.

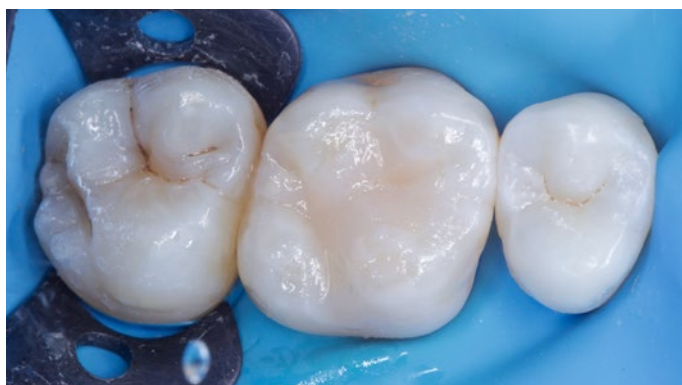
**Fig. 6.**  
Appearance of the tooth after buildup of the restoration with several layers of CLEARFIL MAJESTY™ ES-2 Universal composite (in the shade U developed for the posterior area).

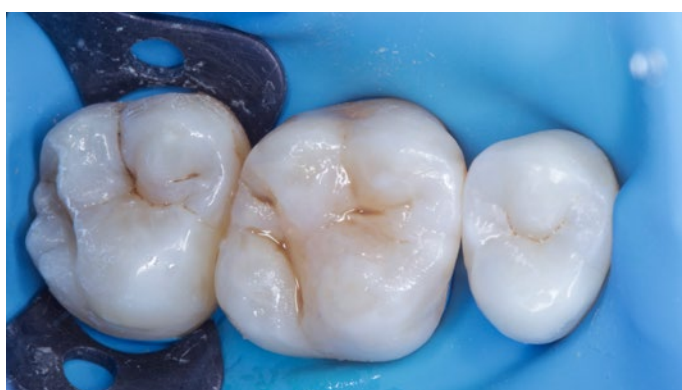
**Fig. 7.**  
Stains applied in the occlusal fissures ensure an even more natural appearance.

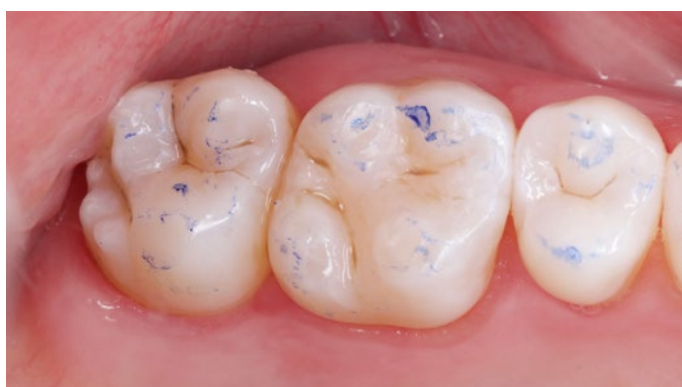
**Fig. 8.**  
Final result after polishing with CLEARFIL™ Twist DIA and checking of the occlusion.

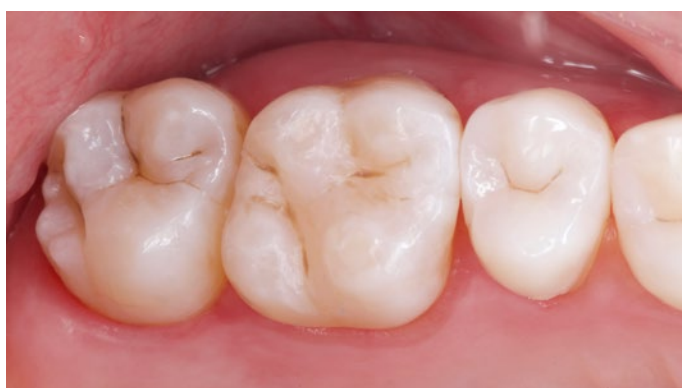
**Fig. 9.**  
Final result immediately after rubber dam removal.

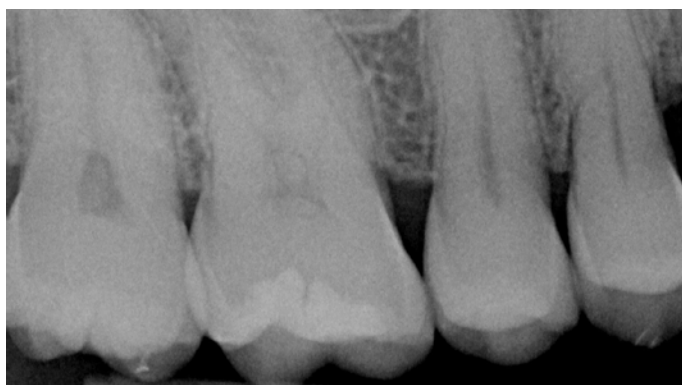
**Fig. 10.**  
Post-operative X-ray.

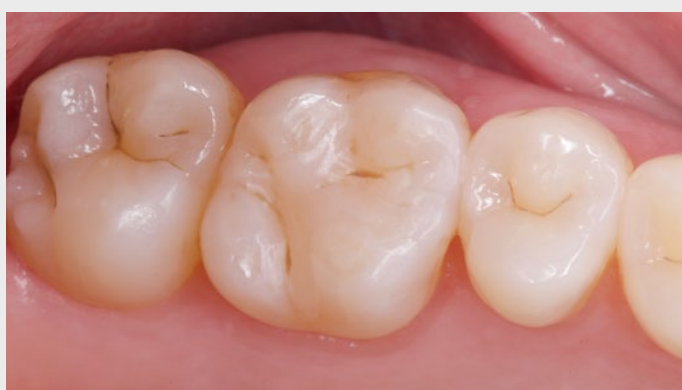
**Fig. 11.**  
Check-up after 15 days with rehydrated dental tissues.
